**Flood Control Project Maintenance  
Levee Inspections**  
**2009 Channel Summary Report**  
**Overall Unit and Item Ratings**

**DWR Sutter Maintenance Yard**

**Flood Control Project Maintenance****Unit Cover Sheet****2009 Channel Inspection Results****DWR Sutter Maintenance Yard**

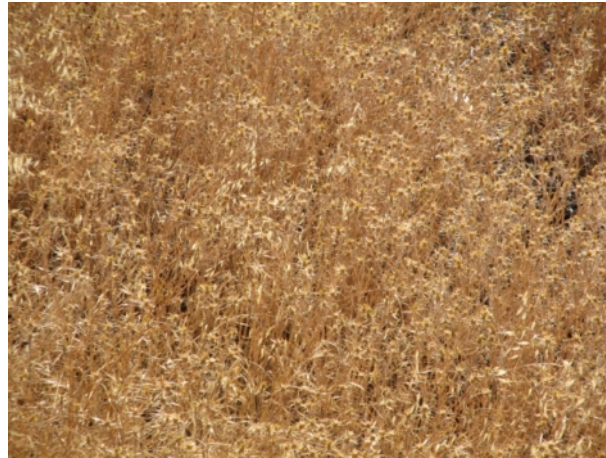
cathom\_20090903\_15.jpg

Up stream of the diversion structure.

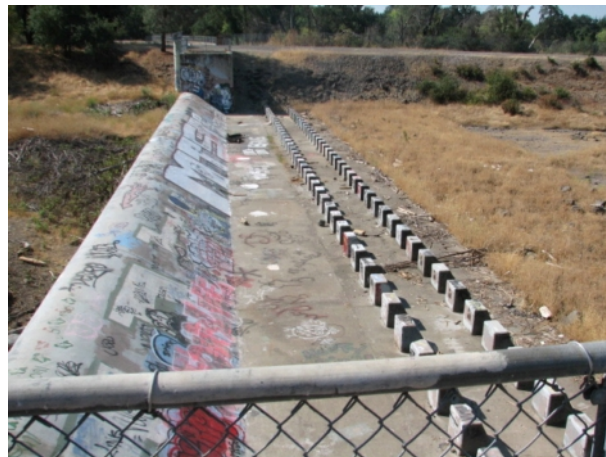
cathom\_20090903\_16.jpg

Levee Mile Report Line	2
Start Levee Mile	0.00
End Levee Mile	0.00
Location	
Category	Channels
Item	Shoaling / Sedimentation

The diversion structure.

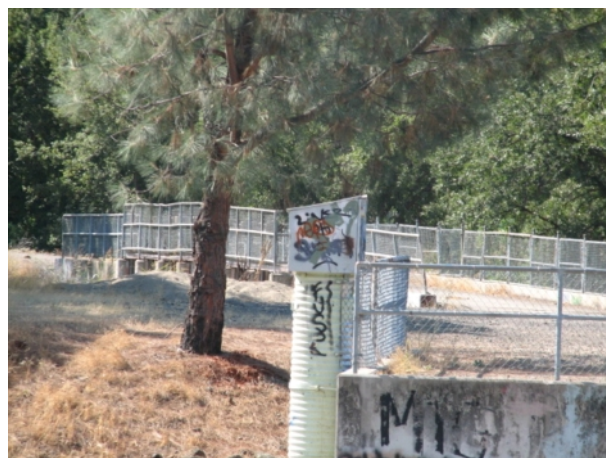
cathom\_20090903\_17.jpg

Levee Mile Report Line	2
Start Levee Mile	0.00
End Levee Mile	0.00
Location	
Category	Channels
Item	Shoaling / Sedimentation

The diversion structure.

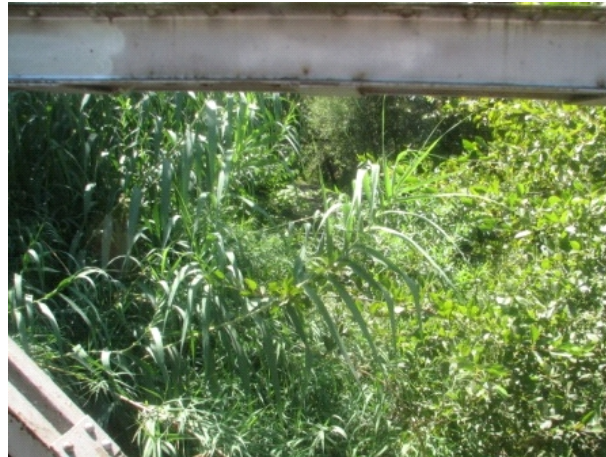
Levee Mile Report Line	46
Start Levee Mile	0.00
End Levee Mile	0.00
Location	
Category	Channels
Item	Vegetation & Obstructions
Down stream from Boucher Street, dense growth on both banks.	
cathom_20090909_54.jpg

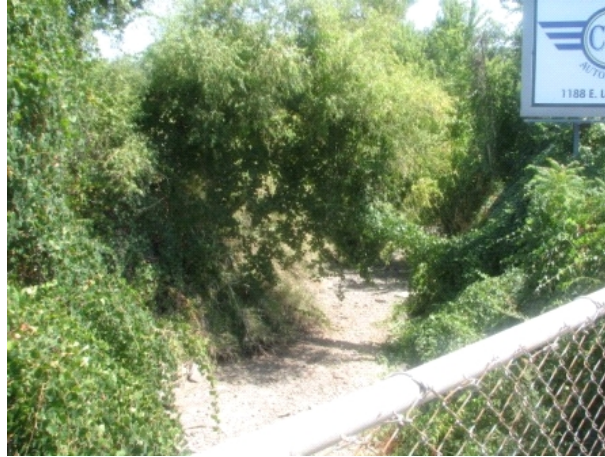
Levee Mile Report Line	61
Start Levee Mile	0.00
End Levee Mile	0.00
Location	
Category	Channels
Item	Vegetation & Obstructions
Up stream from Broadway Street, dense growth on both banks.	
cathom_20090909_57.jpg

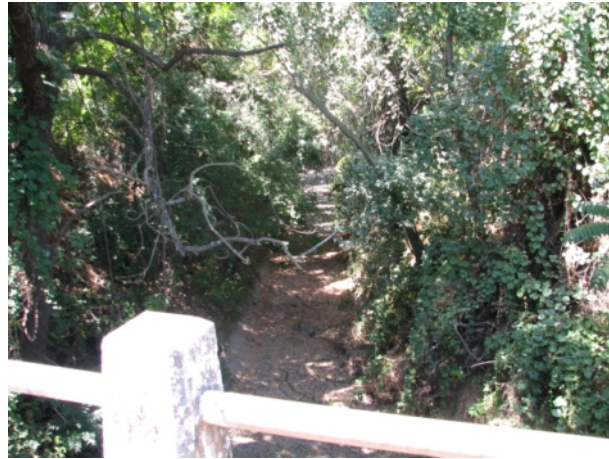
Levee Mile Report Line	76
Start Levee Mile	0.00
End Levee Mile	0.00
Location	
Category	Channels
Item	Vegetation & Obstructions
Down stream from Lone Pine Street, dense growth on both banks.	
cathom_20090909_60.jpg
